Bearing Installation Instructions

Installation instructions

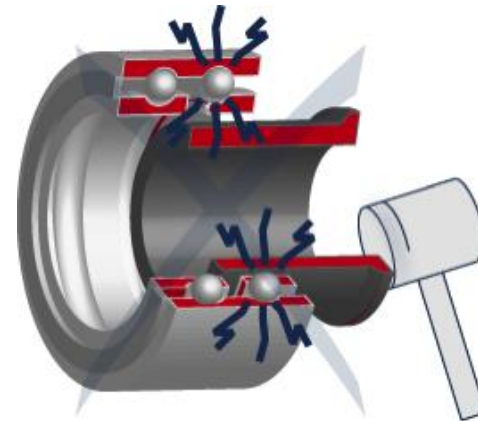
- Hitting the inner ring

- For mounting no mechanical force may be applied.
- When assembling the bearings, make sure that the wheel bearing is not tilted.
- If necessary, special assembly tools should be used.
- The improper use of an impact tool such as hammer should be avoided.

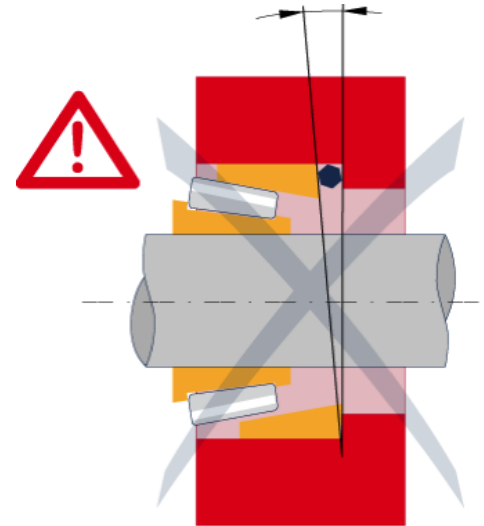
Residues in the bearing seat can cause the disturbance in the functionality of axes;
As a result there might be punctual overloading / peeling.

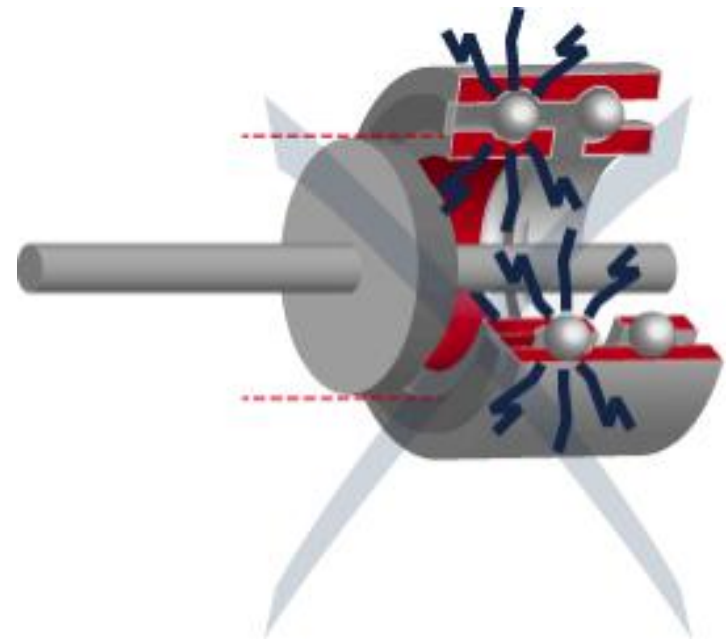
Mounting going over the inner ring.

The result here is an overload of the contact surfaces.
Damage is peeling at rolling element.

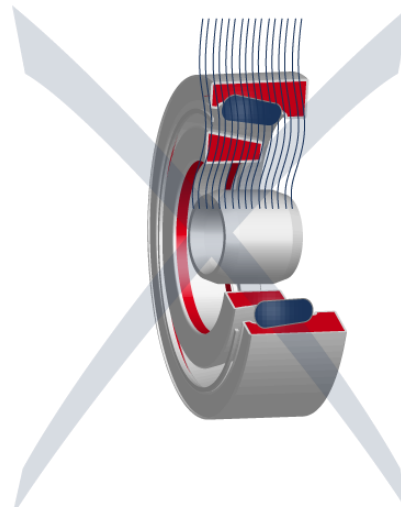
Too small an amount or unsuitable lubricant leads to overheating of the bearing components.

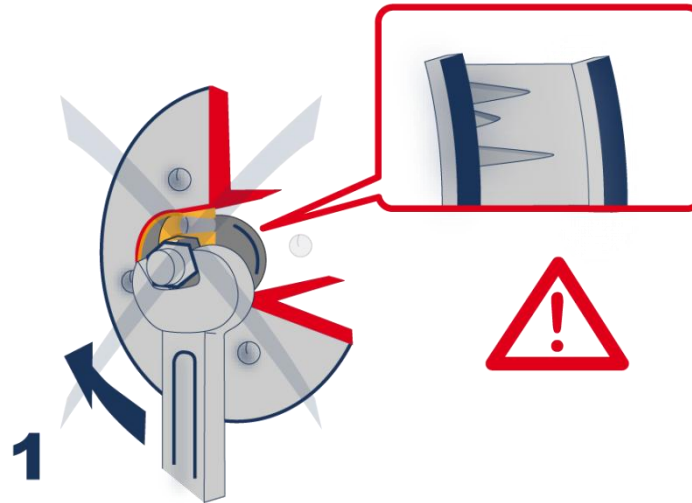
Too high start torque effect which causes the overheating of the bearing components

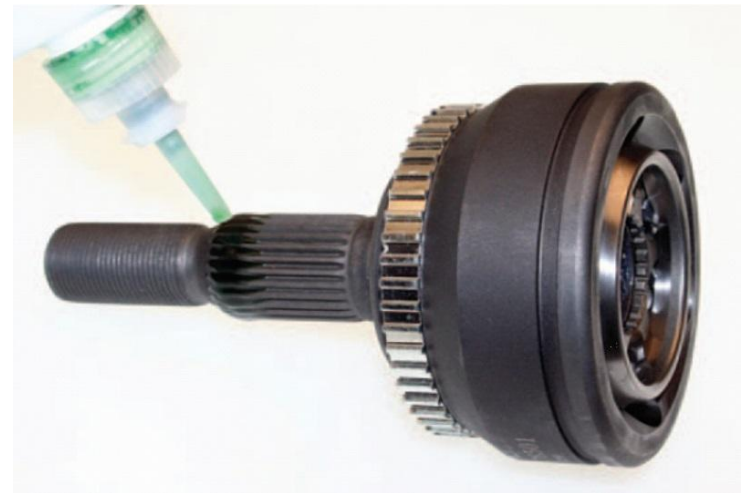
Vibrations and cracking noises in the front area of the axle.

After re joint drive shaft without glue remained minimal clearance between the wheel hub gearing and joint shaft.

Glue the hub with a suitable metal adhesive –
e.g. Volvo.

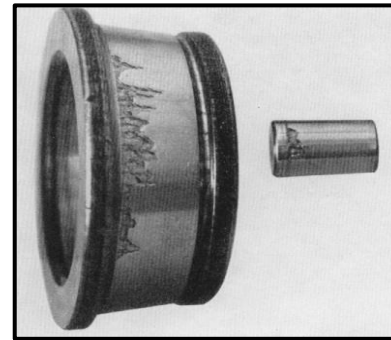
Shelling

is a result of an edge load for tapered roller bearings

- Disruption of functional axes
- Excessive tightening torque

Advanced hulling to
edge loads

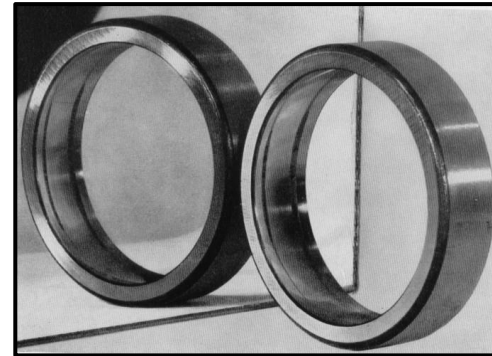
Flattening

is a result of jamming

- Residues in the wheel bearing housing
- Damage to the wheel bearing housing / hub
- Chips, dirt particles between outer ring and housing

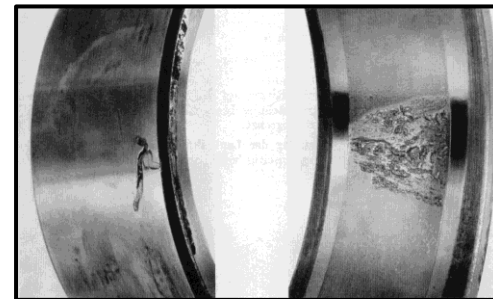
radial load
(Oval jammed
rings)

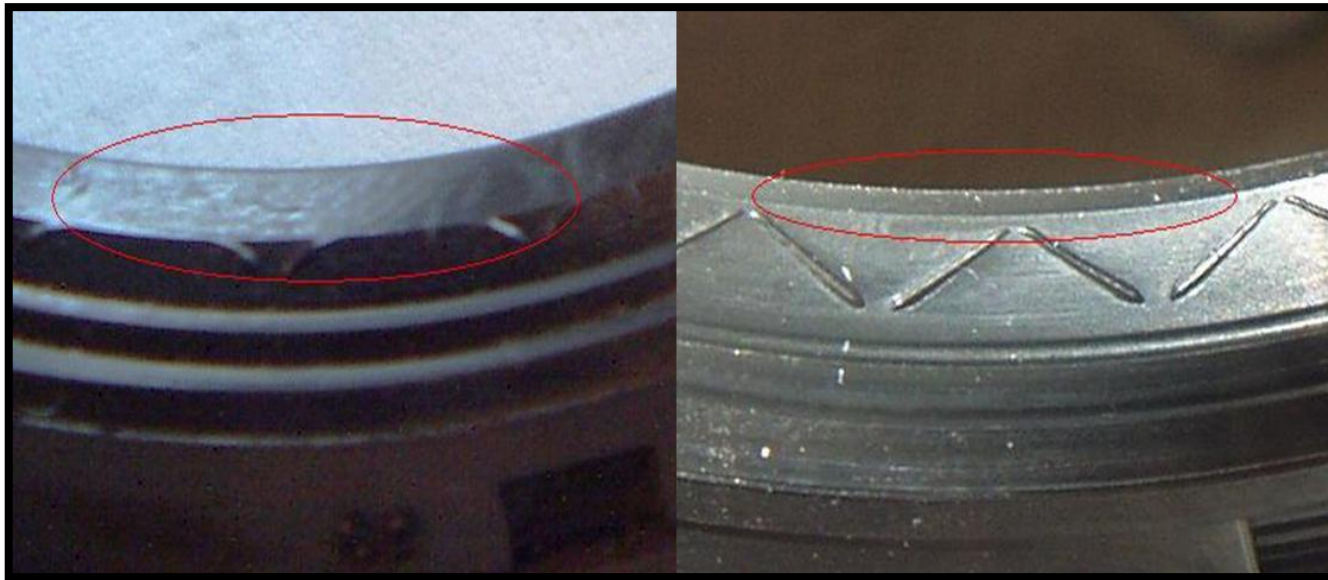
Corrosion

Damage to the wheel hub will destroy the seal.

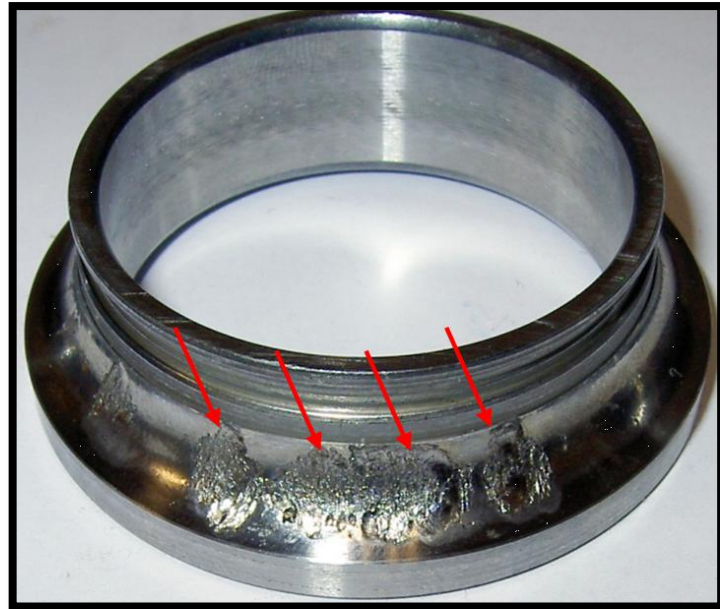
Peeling the roll body distance
Overload of the inner ring
Hitting marks to the inner ring

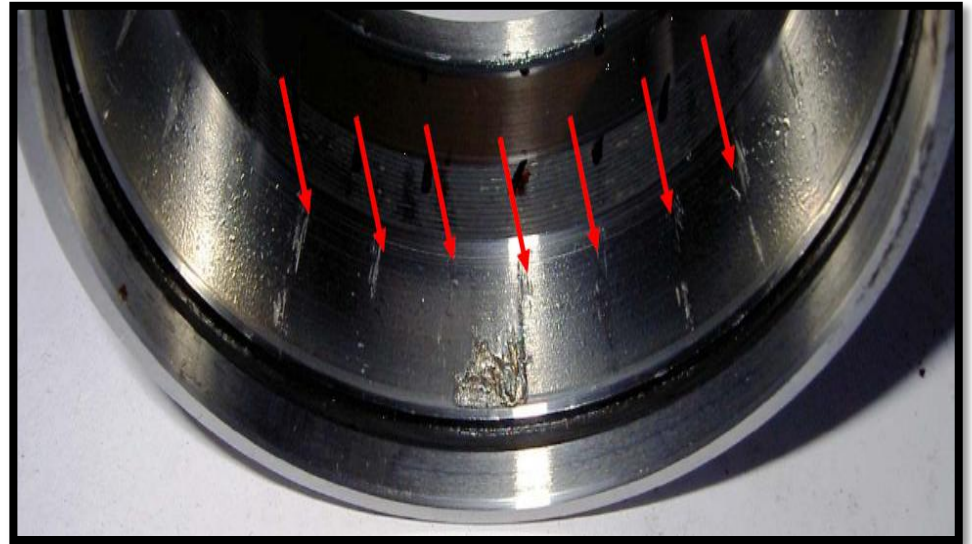
Indentations on the running surface of the
outer ring

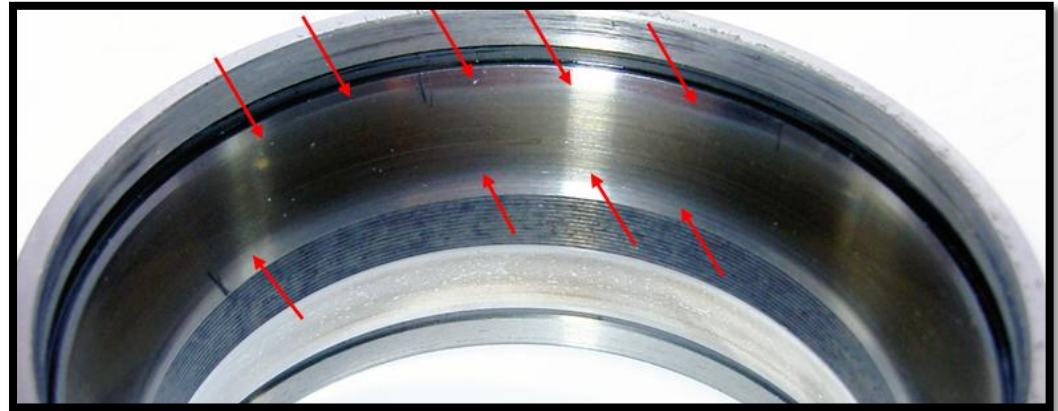
Flattening in the bearing housing

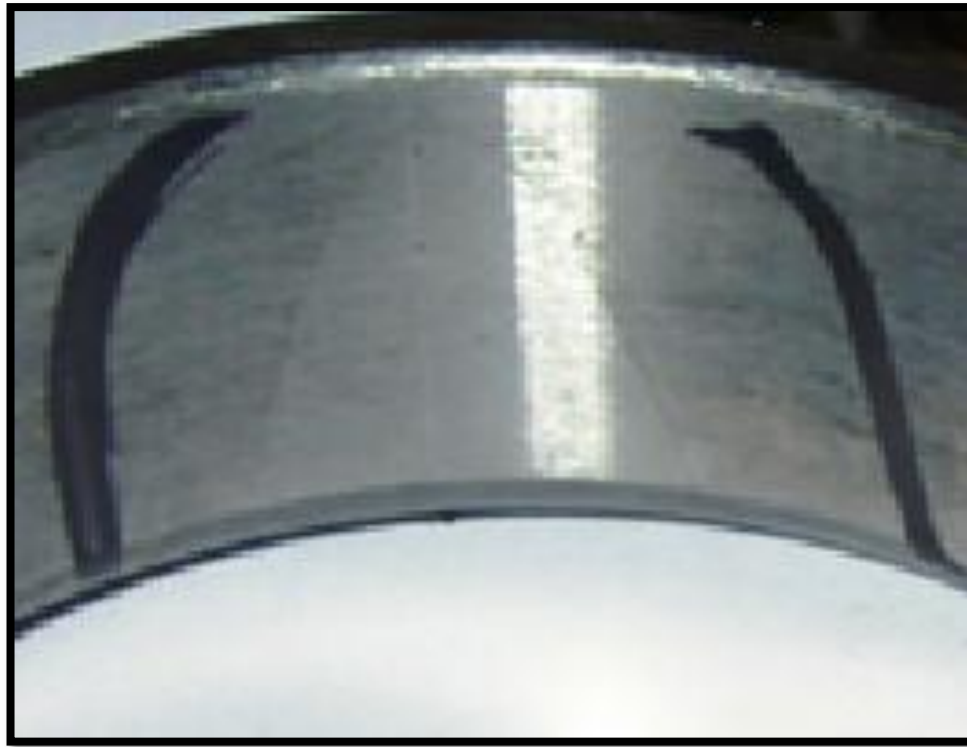
Separate lanes at the tread

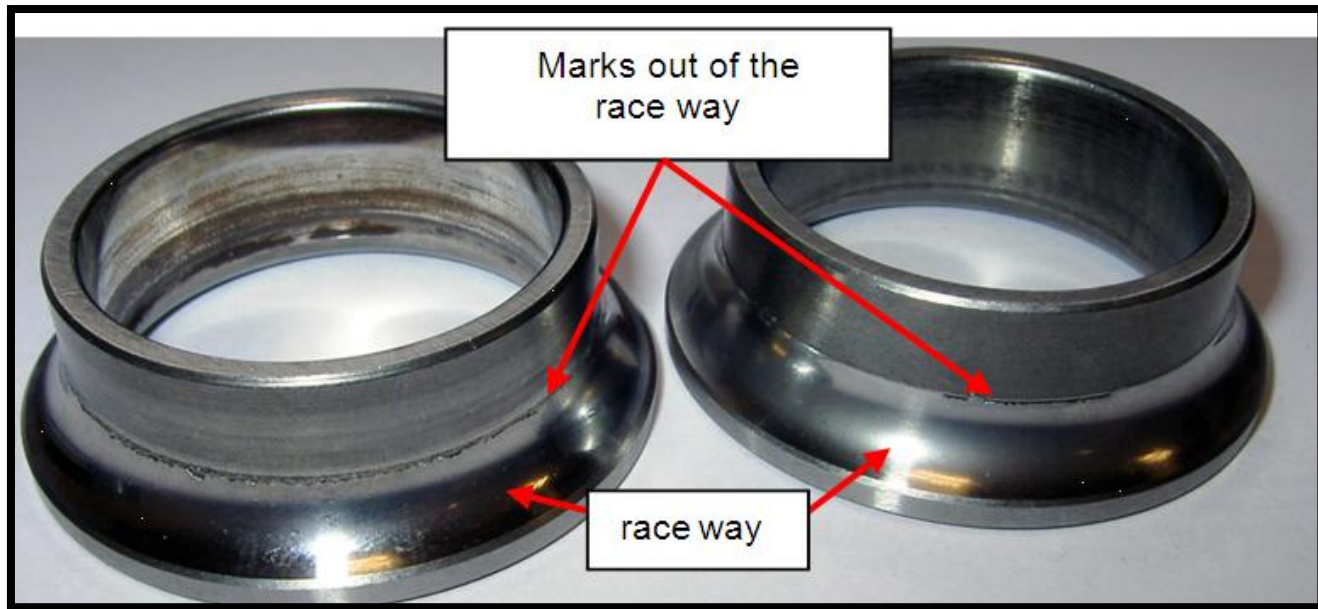
Failure after a short running time

Bearing preload too low

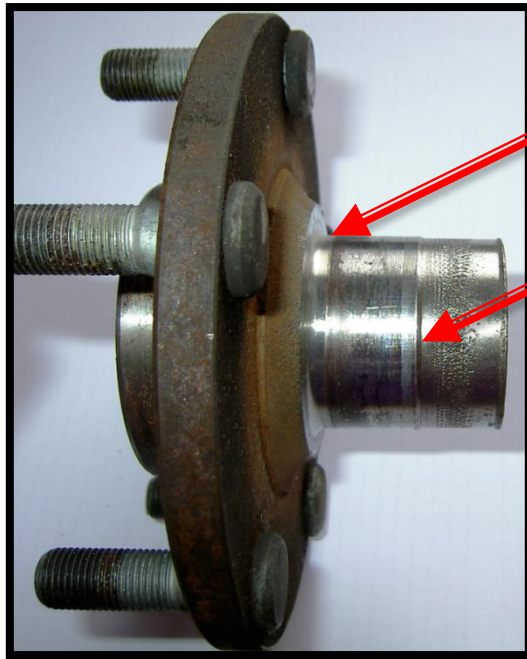
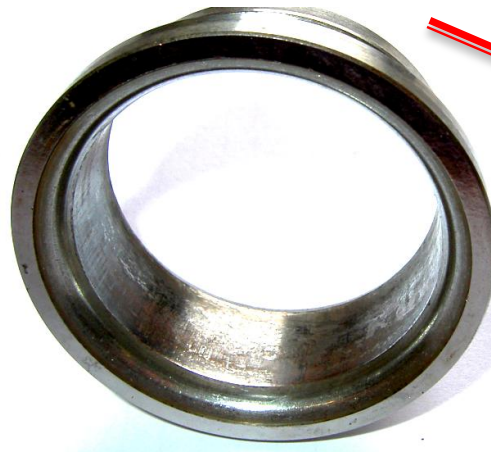
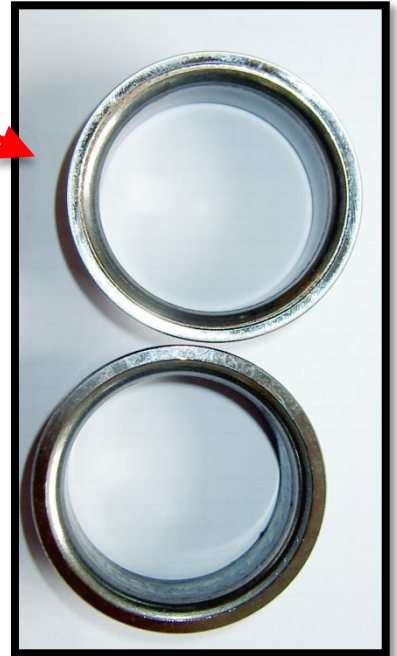
Bearing preload too low

Failure after a short running time

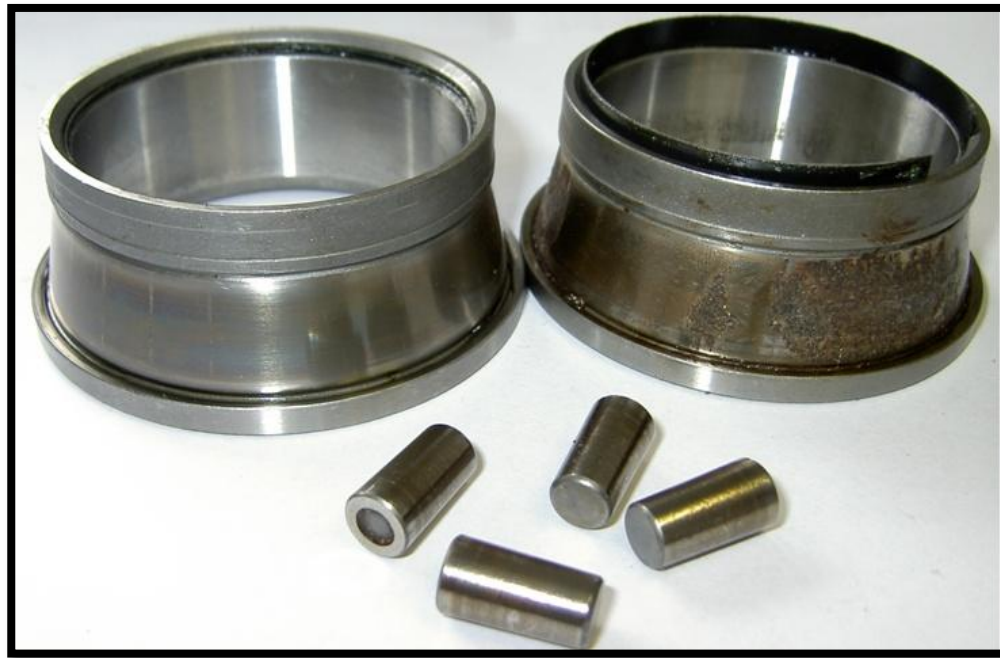
Failure after a short running time

Bearing preload too high

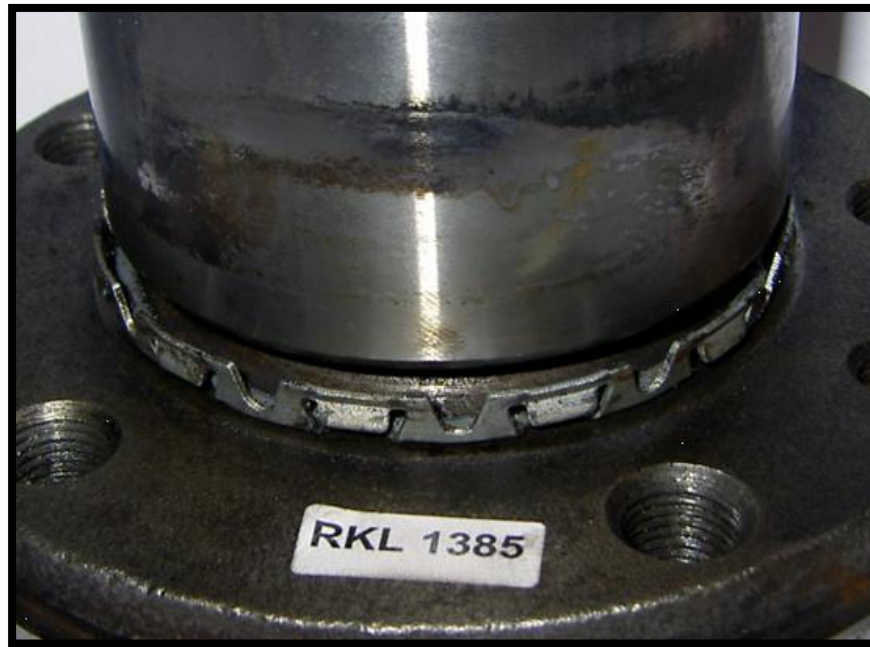
Not mounted using the appropriate tool!

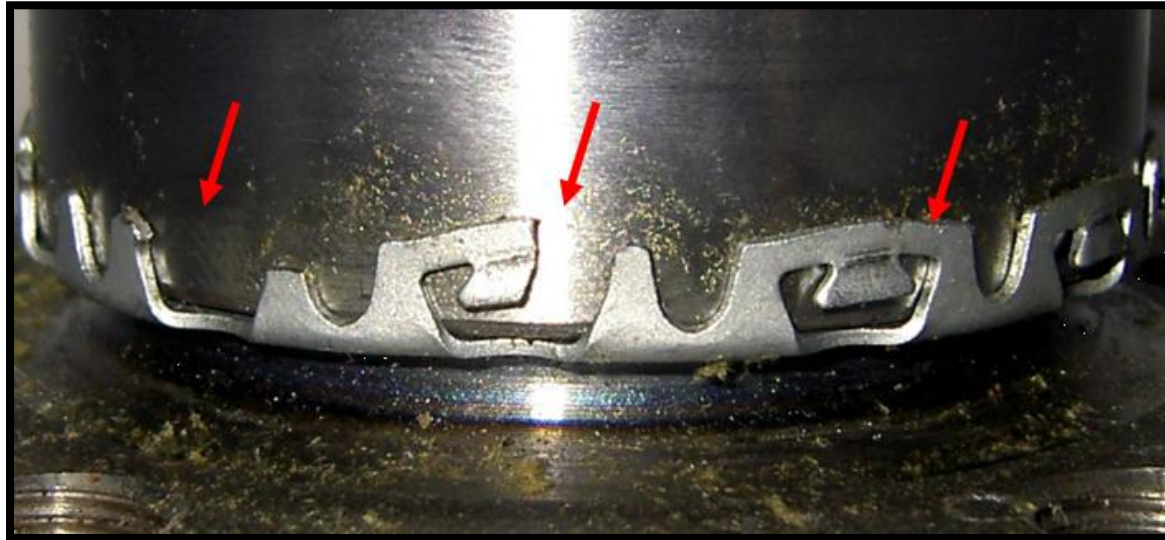
The wheel bearing was fitted correctly!

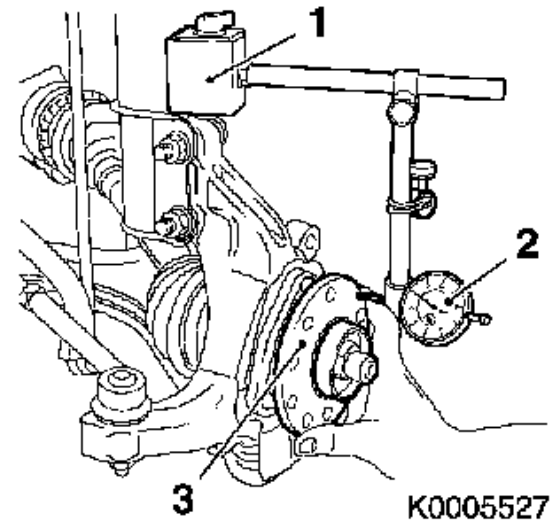
Excessive hub shock caused:

- Noise
- Flapping
- Unequal pad wear
- Poor braking action

Check the runout of the wheel hub according to the manufacturer's instructions!
