THE COMPANY

APPENDIX B - WAYS OF FAILURE

FOREWORD

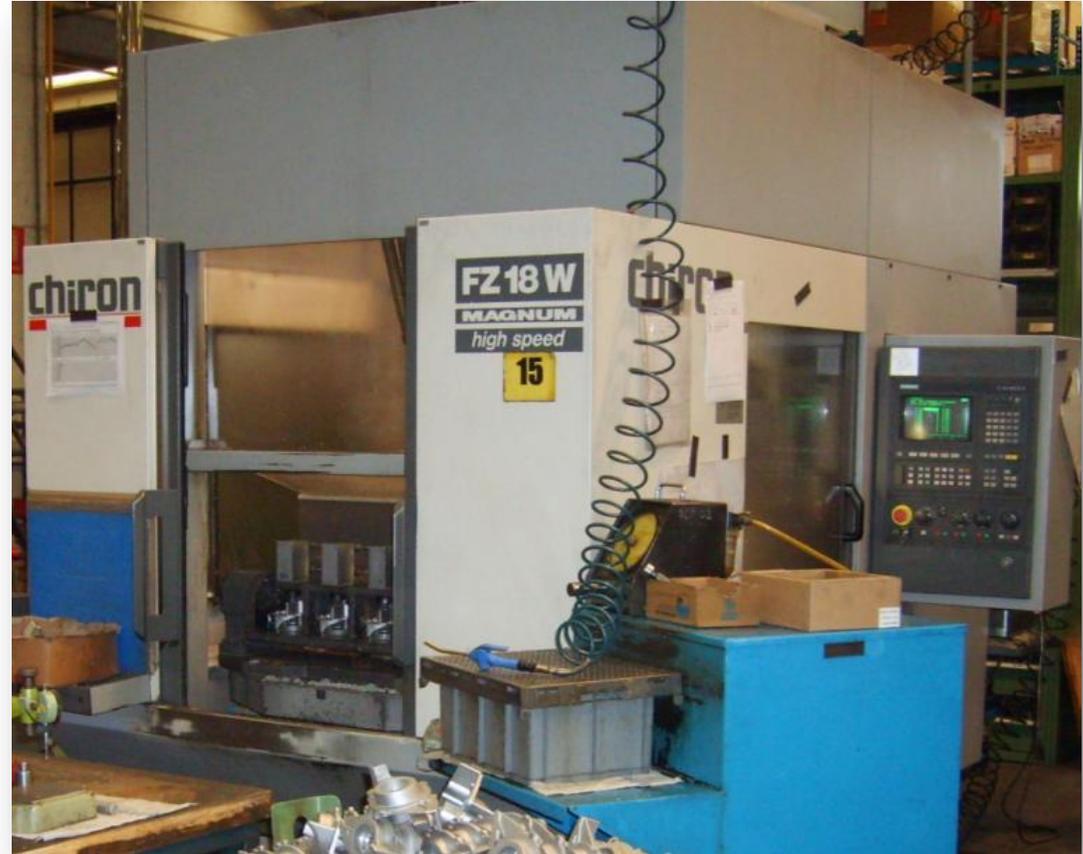
MACHINING

- 2 controlled axis
- auto centering diameter up to 300 mm
- productivity up to 100 pcs/h

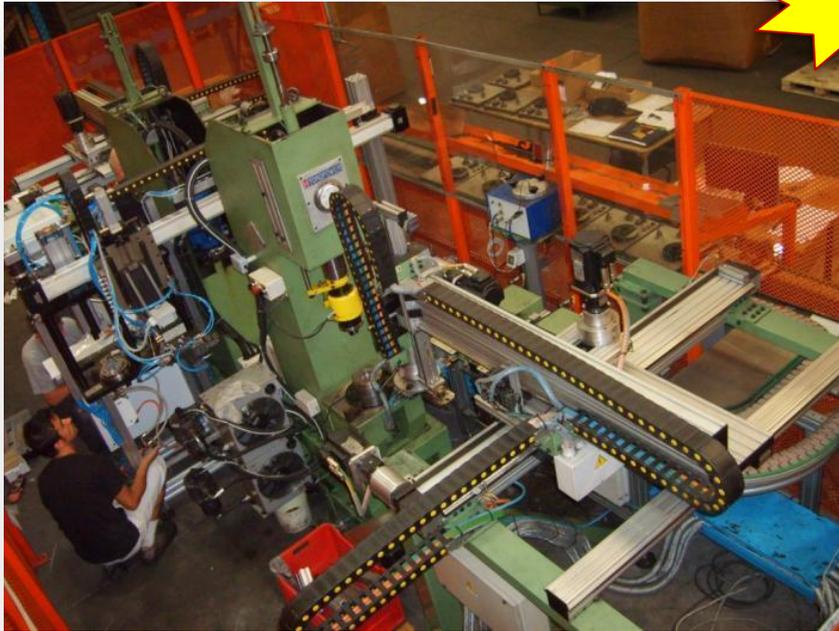
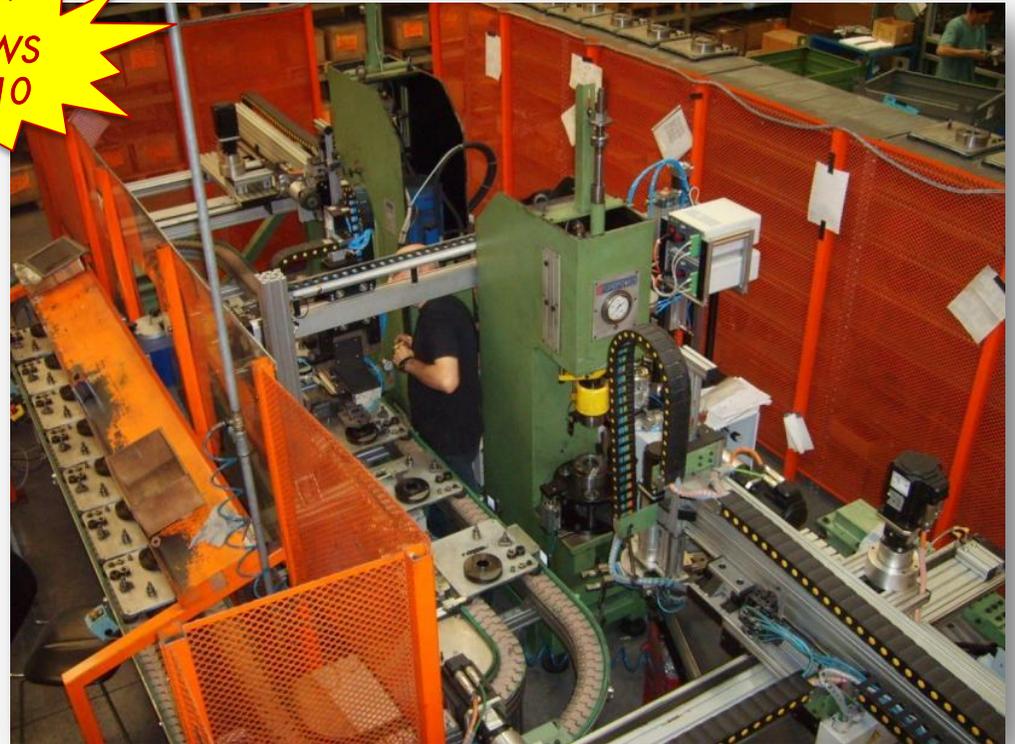
LEAK TEST

After assembly pumps are 100% leak-tested with a special machine for testing the absence of leaks. An automated control will detect discrepant parts and automatically lock them in station to prevent further processing; test success is shown by a green spot on the body pump.

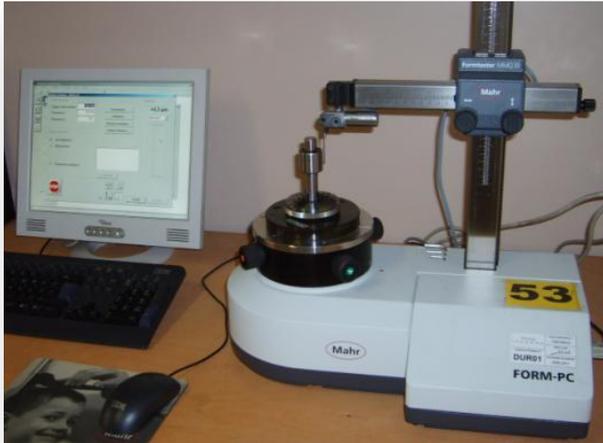
METROLOGY LAB

MEASUREMENT CAPABILITY OF THE LABORATORY:

- 3D coordinate measuring machine WERTH SCOPE-CHECK
- Roundness, concentricity, radial runout
- Hardness Rockwell A, B, C
- Roughness
- Coating thickness
- Vibrations (integral shaft bearings)
- Flatness of lapped surfaces
- Precision balance

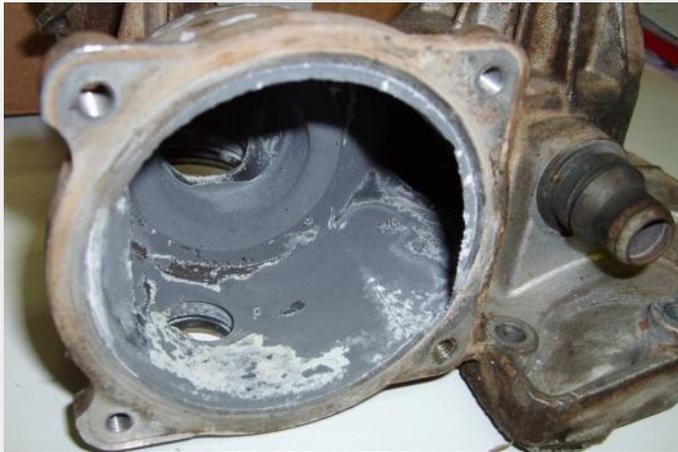
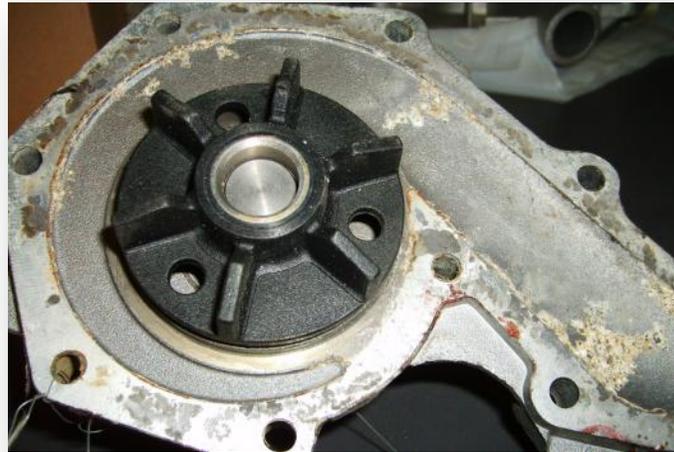
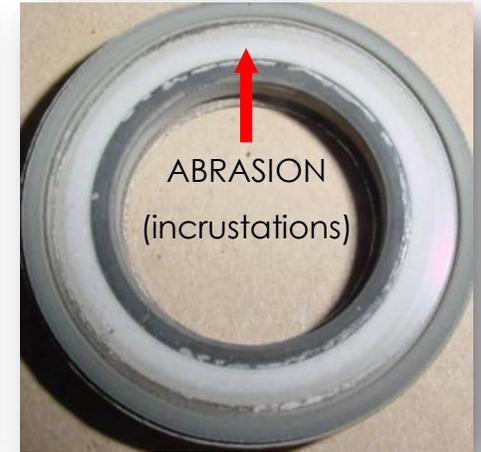
Before installing any new pump it is necessary to thoroughly flush the cooling system to remove any contaminants. These contaminants could also be the reason for the failure of the original pump.

The particles in solution or suspension may damage the sealing surfaces of the mechanical seal which will start to leak. This is why mechanics are advised to wash the cooling system carefully, changing the old fluid and replacing any other rusty or damaged system components.

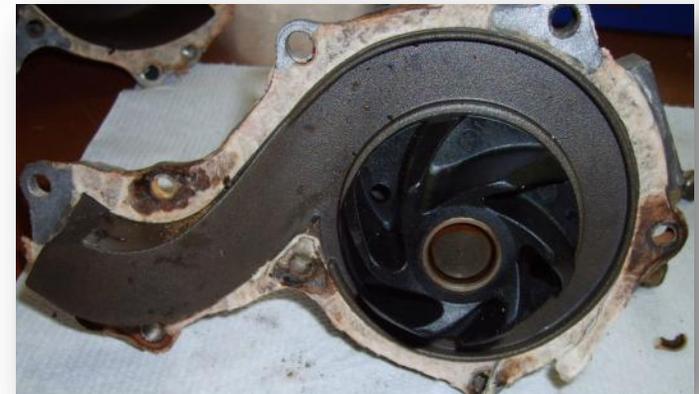
EXCESSIVE USE OF GASKET SEALANT

Excessive use of gasket sealant during installation of pumps leads to strands of sealant detaching from the joint and circulating throughout the cooling system. When sealant particles are present in the coolant they become deposited on the seal faces leading to leakage and, ultimately, pump failure.

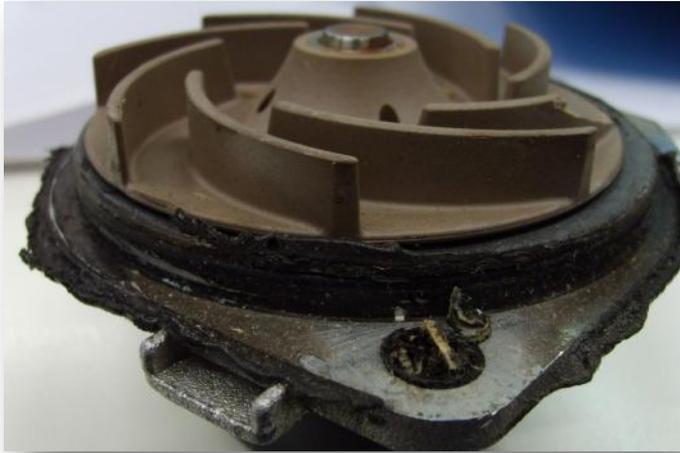
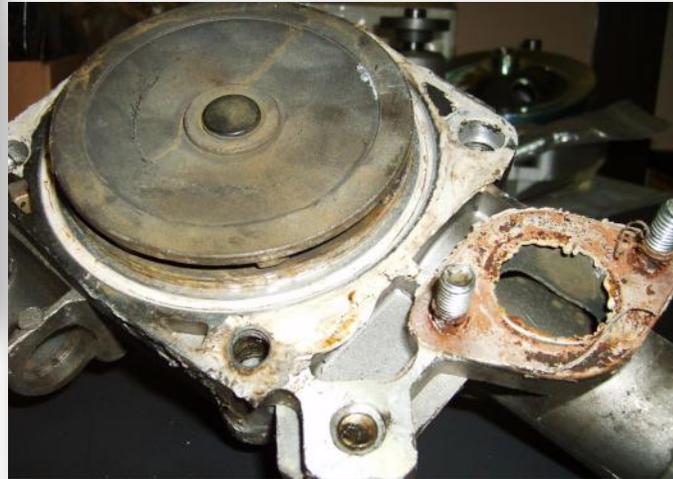
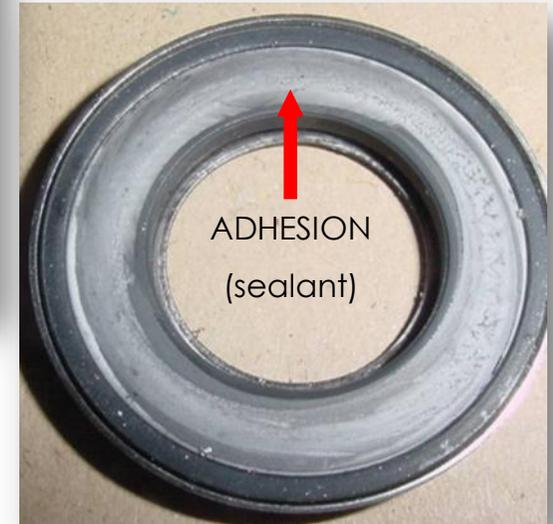
When the pump already has a gasket or an O-ring seal instant sealant must not be used. Many mechanics still like to use it because "they feel safer" when actually they're only menacing the good working of the gasket or O-ring.

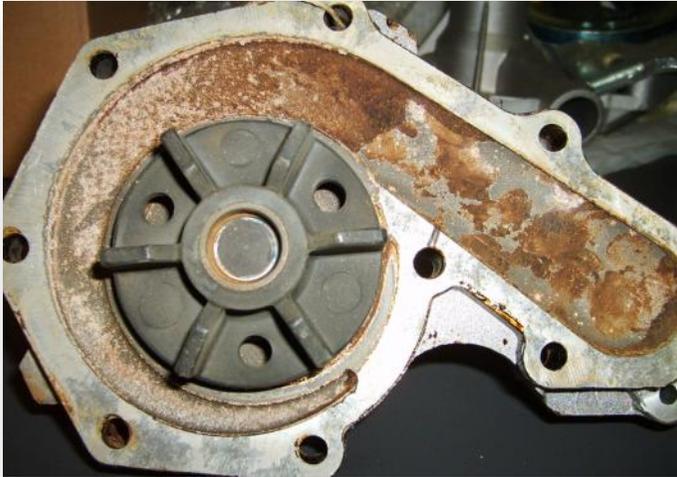
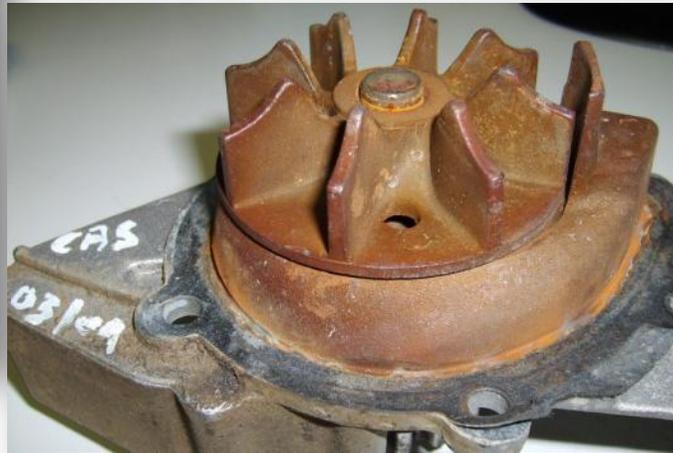
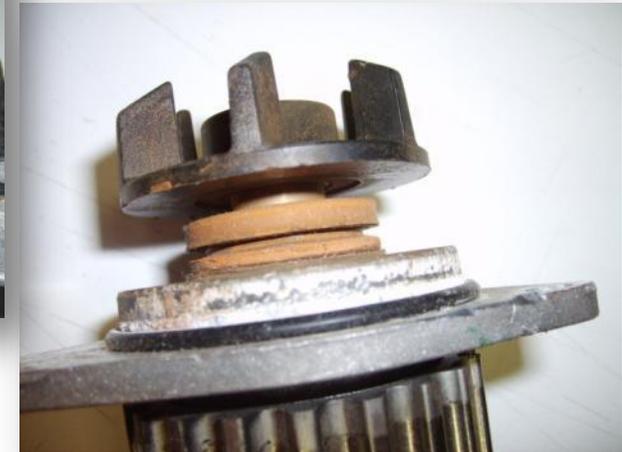
CORROSION

The cooling system should be filled with a coolant solution using a quality antifreeze containing a corrosion inhibitor at the strength determined by the vehicle manufacturer. A corrosive attack results in rust particles circulating throughout the cooling system: these particles become deposited on the seal faces leading to leakage and, ultimately, pump failure.

The coolants recommended by automotive manufacturers are not only antifreeze. They vary due to the different requirements in terms of chemical and physical compatibility with the various materials which make up the cooling system, which include a very wide range of metals, polymers, rubbers and ceramic materials. Nowadays engines work at very high temperatures and that's why coolants are also required to raise the boiling point up to 110°C. Not all coolants on the market are suitable for this, especially those who are not "brand name". No need to say that the use of plain water may cause the complete corrosion of some metals parts of the pump and cooling system.

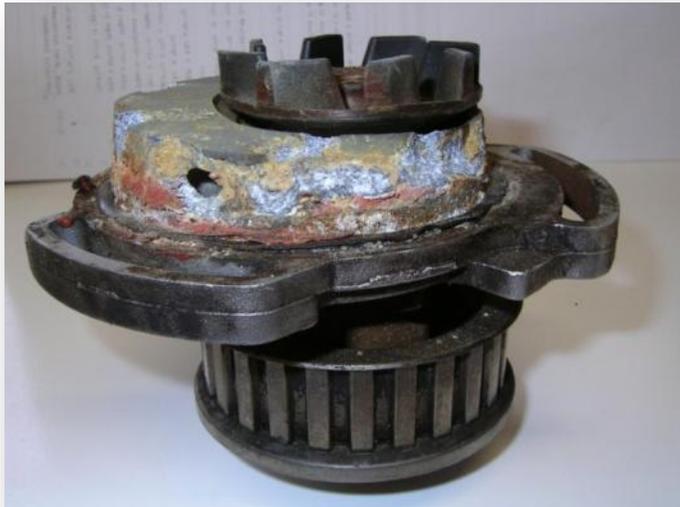
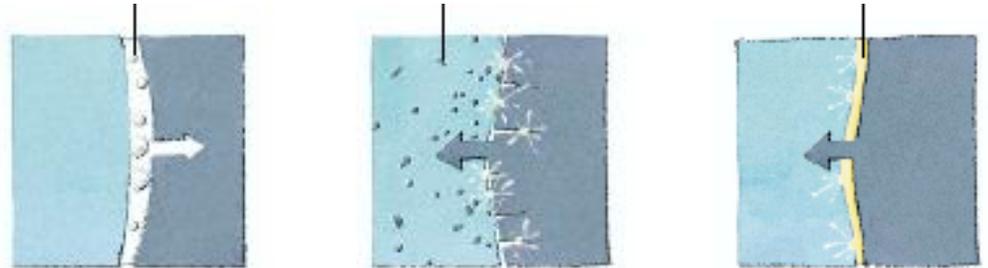
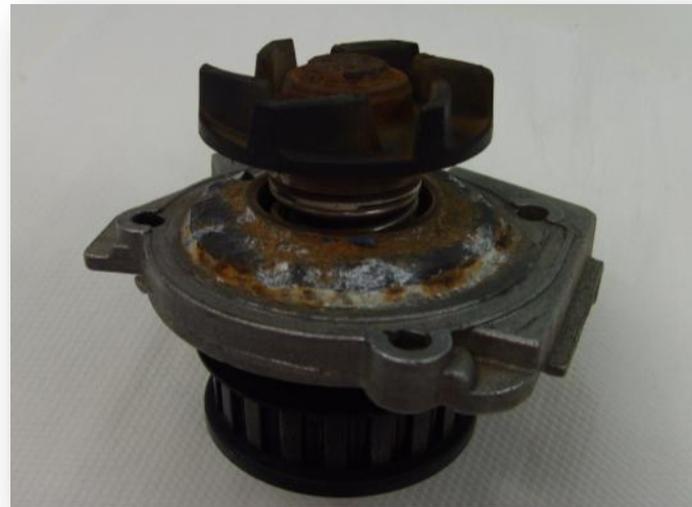
CAVITATION AND EROSION

Air cavities may develop in the cooling system during refilling and they can be trapped if the system is not carefully bled allowing the air to be expelled. The air cavities driven by the flow in a region of high pressure (e.g. round about the impeller) will implode and generate high-pressure pulses leading eventually to erosion.

Air cavities may also develop when the temperature goes over the boiling point of the coolant. This is another reason why the use of a branded coolant is highly recommended.

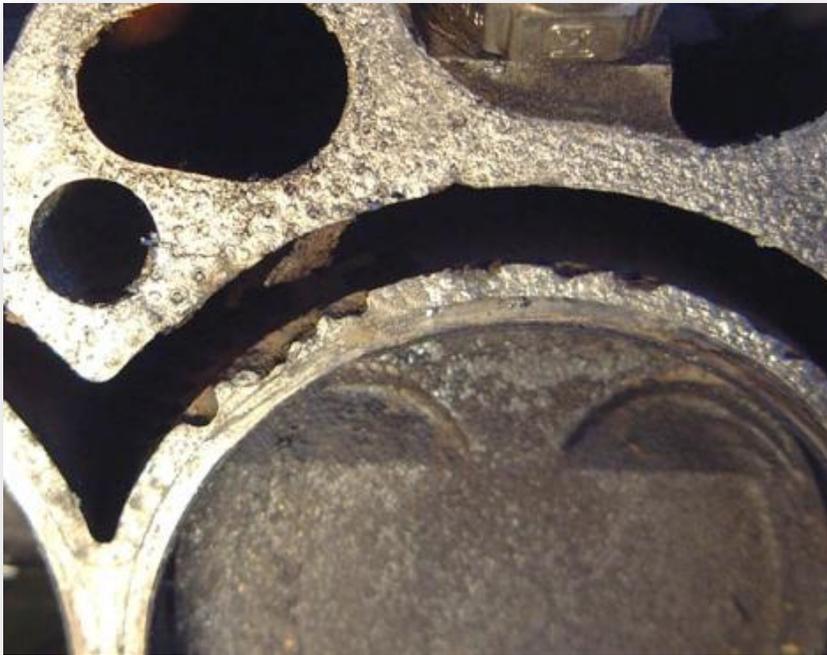
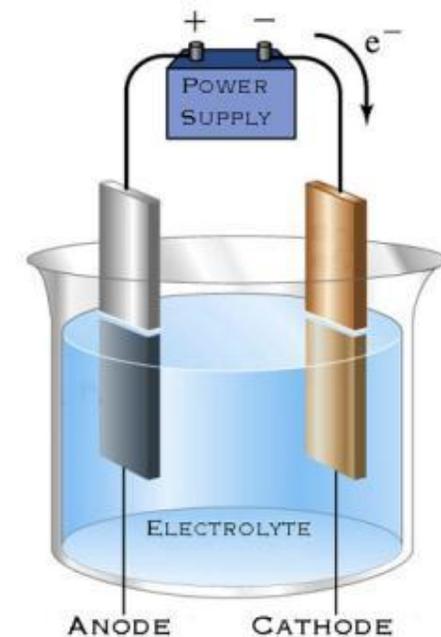
ELECTROLYSIS

Electrolysis is erosion caused by an electrical current generated by dissimilar metals bathed in acidic fluid (pH below 7.0). When this phenomenon takes place the aluminium parts of the cooling system (engine block, water pump) work as the anode: the aluminium undergoes oxidation and it is transferred to the iron parts of the cooling system.

In the case of the water pump the erosion will likely cause the clearance between the housing and the impeller to increase, reducing the flow of coolant and leading to overheating.

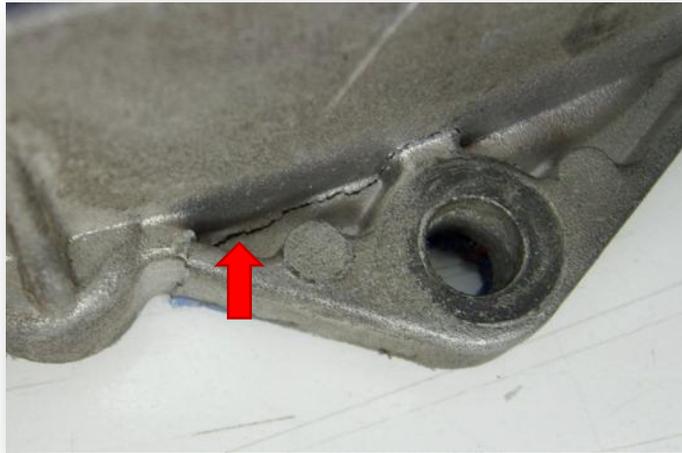
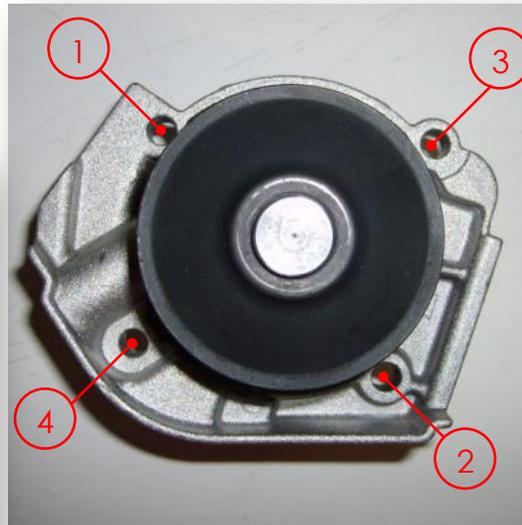
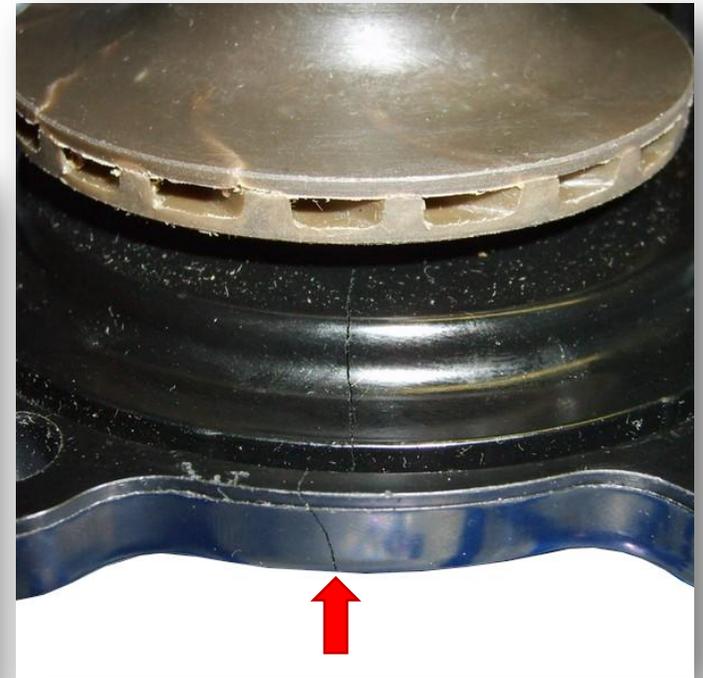
CRACKING OF THE BODY

It is quite unlikely that cracking of the body is due to the presence of a blow-hole in the cast; anyway, if so, it is clearly visible on the crack surface.

Body crackings are mostly due to overtightening of screws. It is very important that screwing torque complies with the manufacturer manual. It's also important to tighten the screws following an alternate order, to avoid tension to be generated in the body.

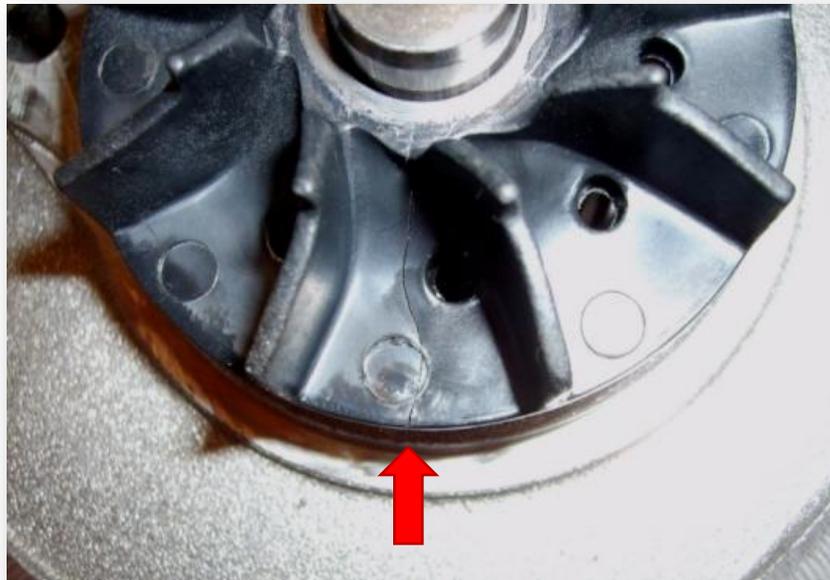
CRACKING OF THE IMPELLER

While a pump with a broken impeller is easily identifiable and unlikely to be assembled even by an inexperienced as careless mechanic, a pump whose impeller has only cracked (see photo below) could be fitted even by a very experienced mechanic. Since the speed of rotation of the impeller is proportional to the speed of rotation of the engine, it is not difficult to imagine how the forces acting on the impeller during its operation will lead in a short time to a failure with detachment of the plastic part from the bush.

We recommend to always check that the impellers are free from defects before installing the pump.

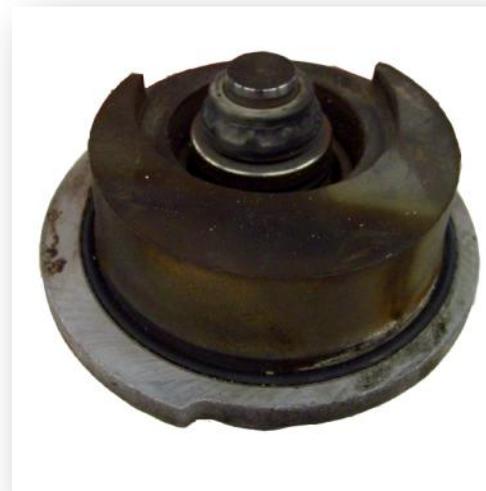
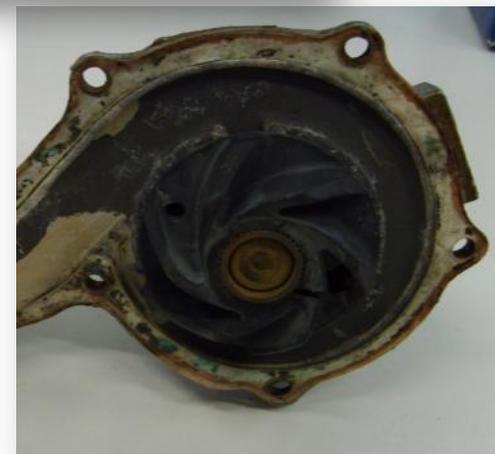
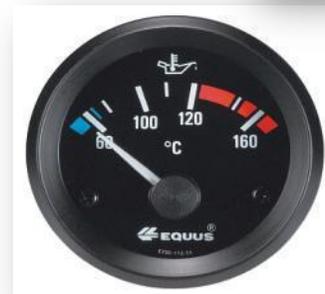
OVERLOAD

A wrong tension of the belt is still a quite common reason for failure, even if the widespread use of automatic tensioners *might* lead to believe that it is impossible to set up the belt tension wrongly. Failure of the timing belt often involves huge repair costs and that's why mechanics don't like to take their responsibility about this.

When one of these situations happen, the bearing analysis can tell us if a condition of overload actually existed: in fact the bearing works as a second-class lever (nutcracker) where the row of balls on impeller side is the "fulcrum", the belt tension is the "input effort" and the row of balls on pulley side generates the "output load".

When a condition of overload exists, the rolling elements of the bearing will show signs of overheating. If the bad working condition is protracted and/or combined with other bad working conditions (for example a leaking mechanical seal, with coolant seeping into the bearing), the rolling elements will start to degrade, showing signs of rust, pitting and corrosion.

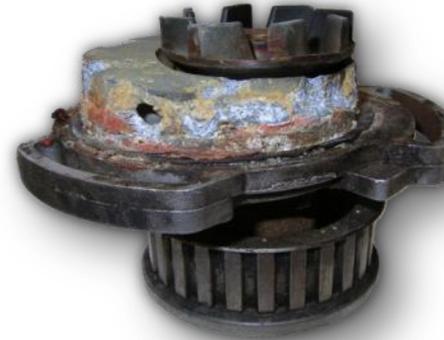
PA31001
mileage: 10.000 km

INADEQUATE COOLANT

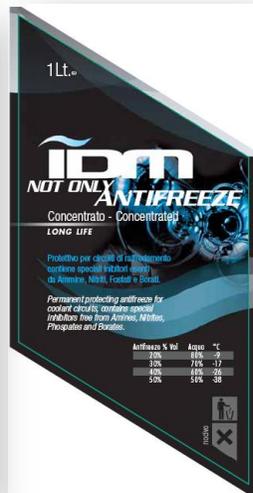
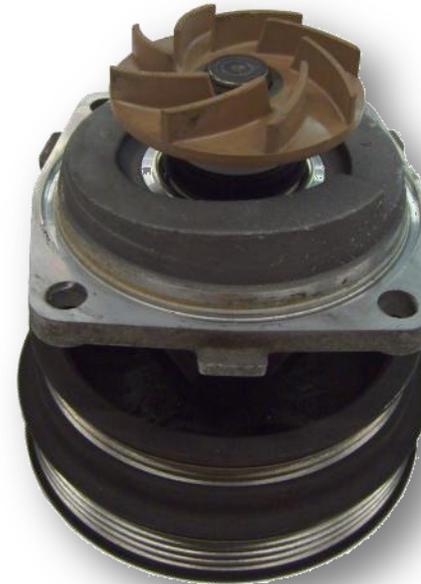
PA30090
mileage: 100.000 km

QUALITY COOLANT

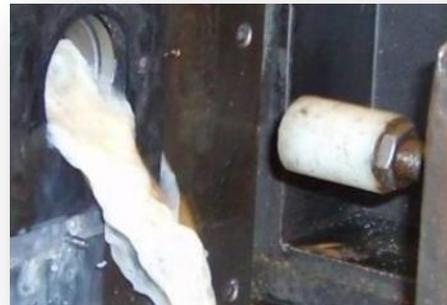
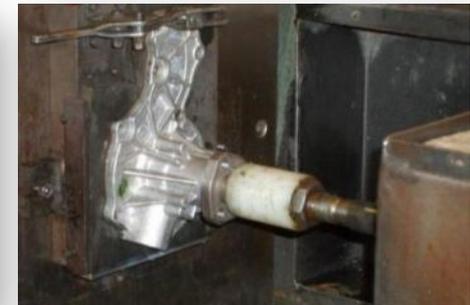
STATIC LEAK TEST AT -20°C

Specifications requirements: fit the pump on the test equipment filled with cooling liquid; put the pump inside the freeze room and set the temperature to -20 °C; process the system for **30 minutes** with an internal pressure of **1.5 bar**. No leaking (no drops) is admitted at the drain-hole.

RESULT	NOTES
IDROMECC	OK	No leak detected
COMPETITOR A	OK	No leak detected
COMPETITOR B	OK	No leak detected

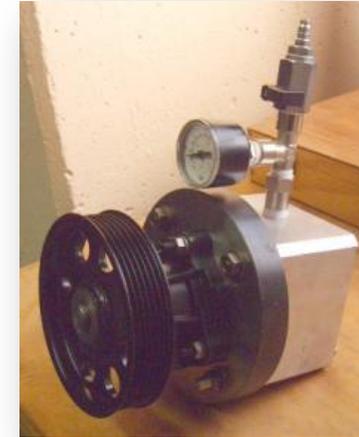
DYNAMIC LEAK TEST

Specifications requirements: fit the pump on the test bench and set the temperature to +90 °C; when the room temperature is stable close the outlet valve and process the pump for **5 minutes** with an outlet pressure of **1.5 bar**. No leaking (no drops) is admitted at the drain-hole.

RESULT	NOTES
IDROMECC	OK	No leak detected
COMPETITOR A	OK	No leak detected
COMPETITOR B	OK	No leak detected

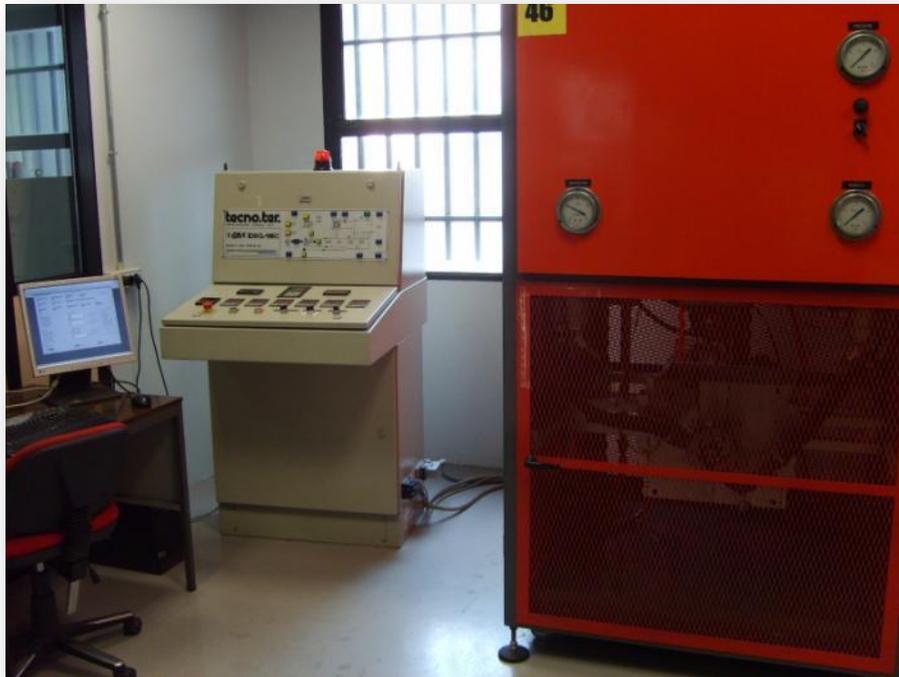
Specifications requirements: fit the pump on the test bench and, with the inlet valve fully open, set the temperature to **+25 °C**; at various values n_i of the speed of rotation*, detect the curve head H / flow rate Q .

Picture of the test bench for performance test

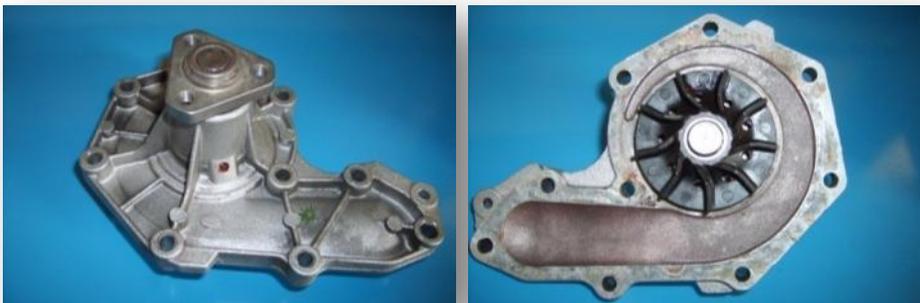
IDROMECC - PA37034

IDROMECC	RESULT	NOTES
PA37034	OK	No leak detected

IDROMECC pump began to leak after 780 h , the bearing was still working correctly.

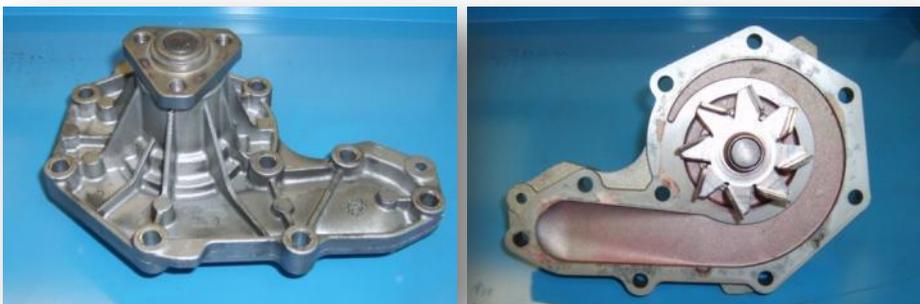
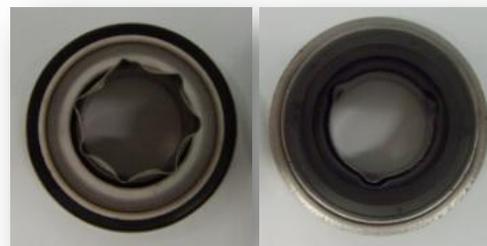
COMPETITOR A	RESULT	NOTES
PA37034	OK	No leak detected

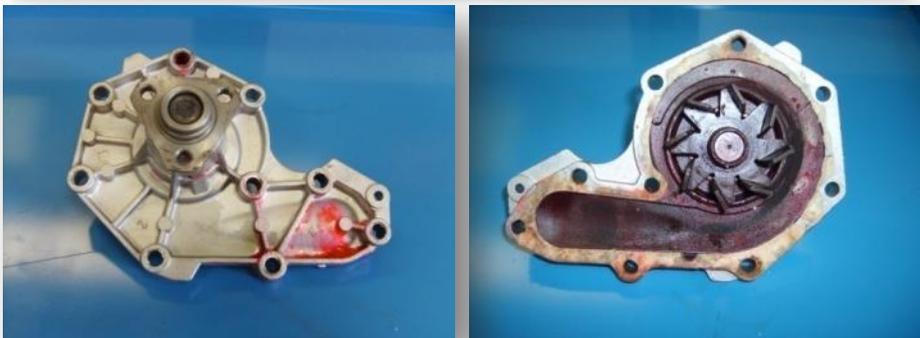
COMPETITOR B	RESULT	NOTES
PA37034	NO	Leaking after 374 h

COMPETITOR B's pump began to leak after 374 h , the bearing was noisy and showed signs of overheating which means that it was going to fail

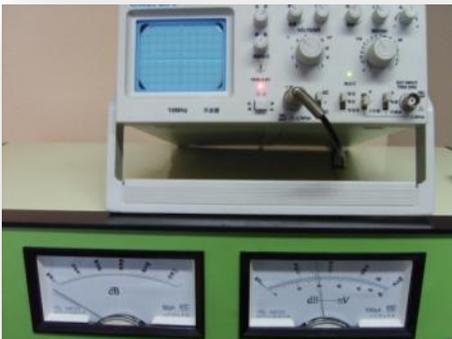
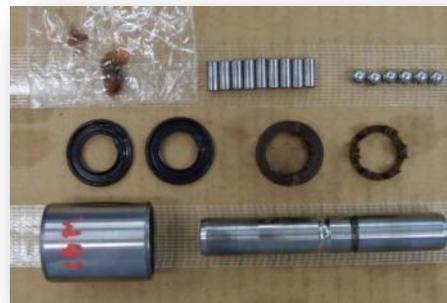
IDROMECC - PA37034

INNER STRUCTURE:
6 balls $\varnothing 6.345$
9 rollers $\varnothing 4.80 \times 11.8$
HARDNESS:
shaft - 61.0 HRC
raceway - 62.5 HRC
balls - 61.0 HRC
rollers - 61.5 HRC

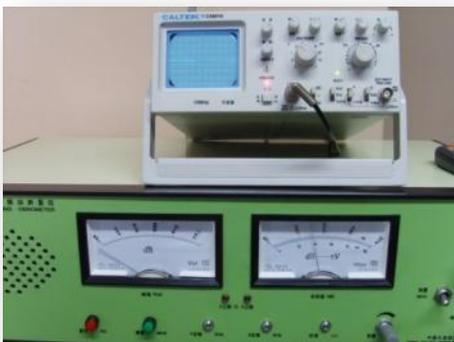
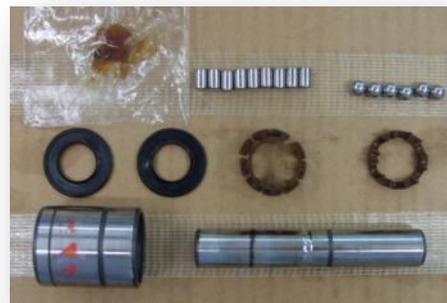
COMPETITOR A

INNER STRUCTURE:
6 balls $\varnothing 6.345$
9 rollers $\varnothing 5.00 \times 8.0$
HARDNESS:
shaft - 61.5 HRC
raceway - 63.0 HRC
balls - 61.0 HRC
rollers - 61.0 HRC

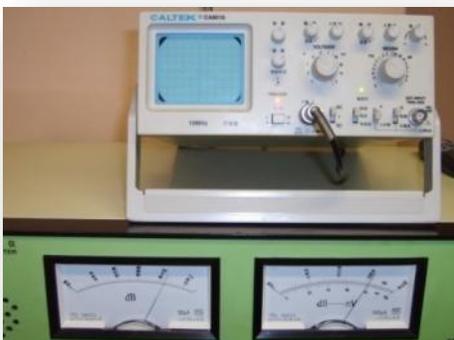
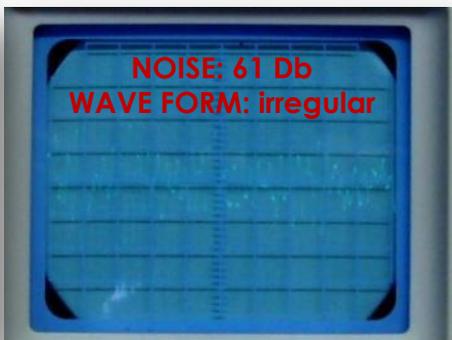
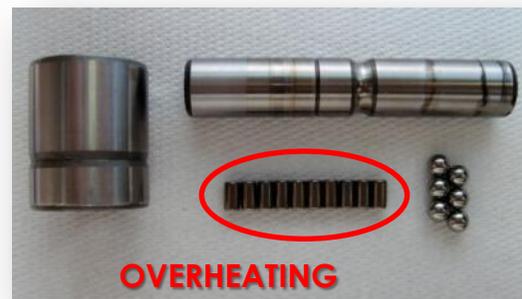
COMPETITOR B

INNER STRUCTURE:
6 balls $\varnothing 6.345$
10 rollers $\varnothing 4.50 \times 8.0$
